Federal Public Service
Mobility and Transport
Air Accident Investigation Unit

Safety Investigation Report

ACCIDENT TO PIPER PA-44-180 AT EBST ON 11 SEPTEMBER 2011

Ref. AAIU-2011-23
Issue date: 14 January 2013
Status: Final

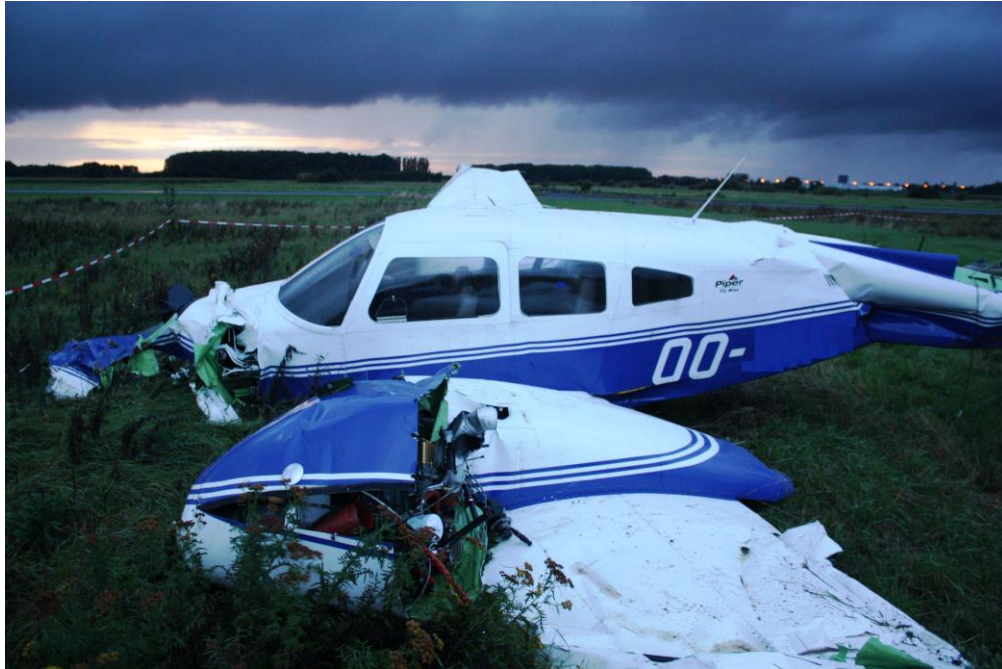
Figure 1: view of the airplane as seen just after the crash

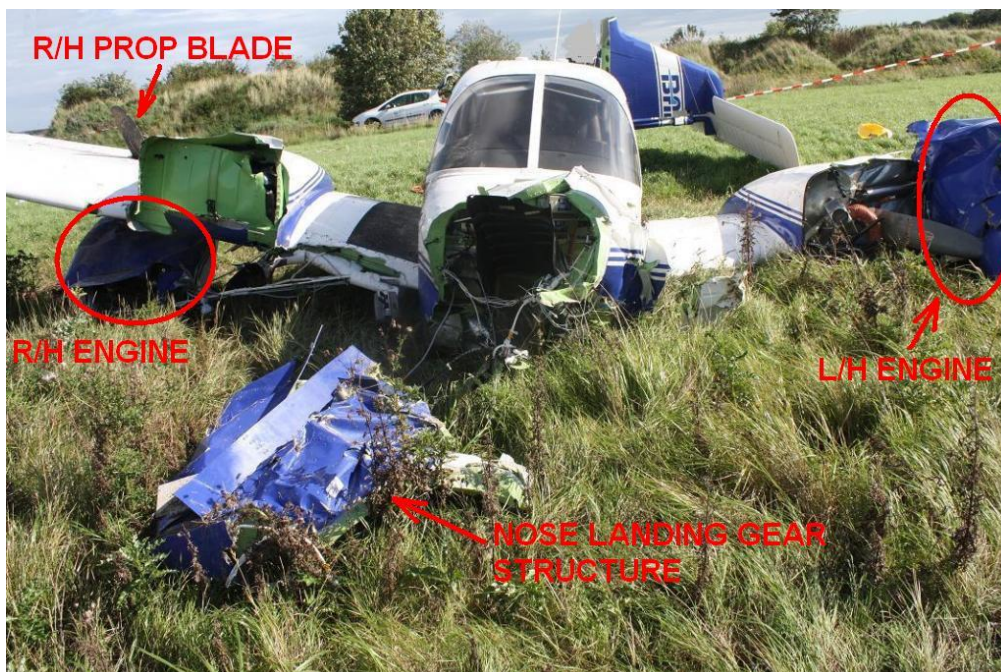
Figure 2: airplane as seen the day after the crash

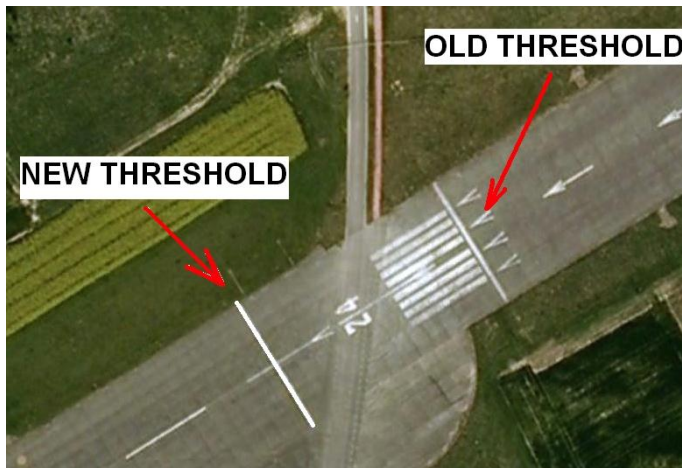
The thresholds of the present 1.199 m long airfield are materialised by simple white transversal lines while the old military (significantly longer runway) thresholds markings have not been removed.

Figure 6: View of the new and the old threshold

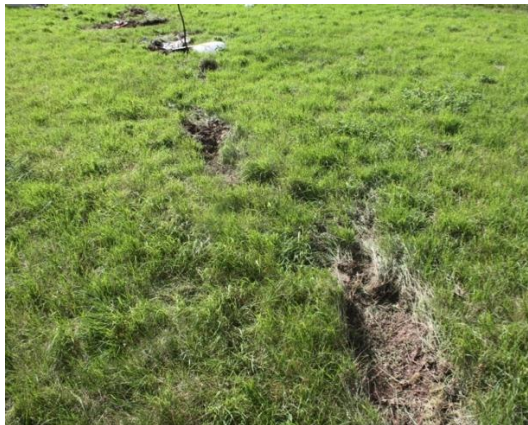
Figure 9: first significant impact traces

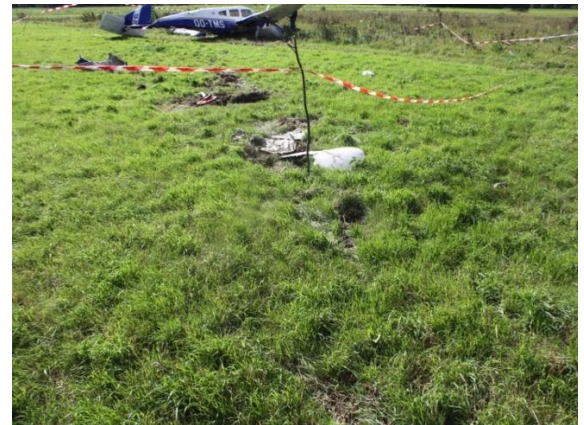
Figure 10: last impact traces with airplane in background

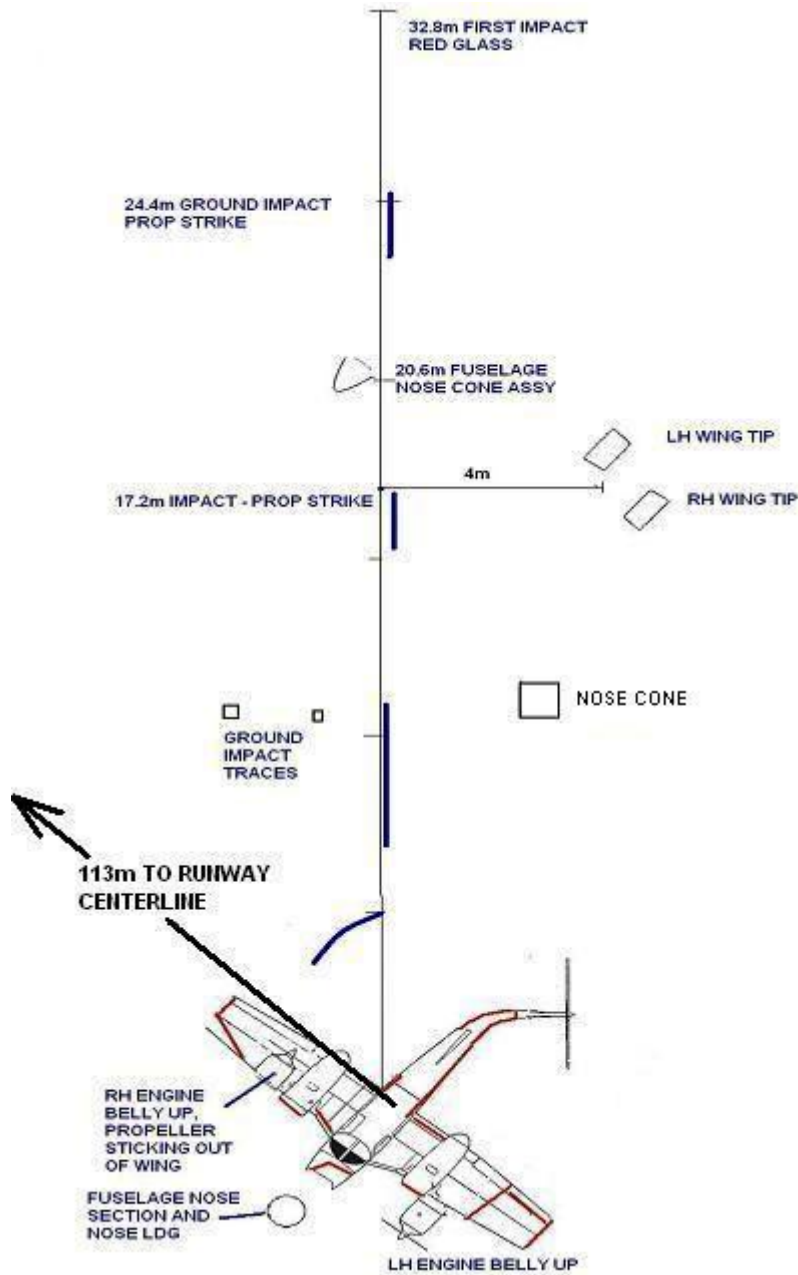
Figure 11: Position of the different impacts and remains (Not to scale).

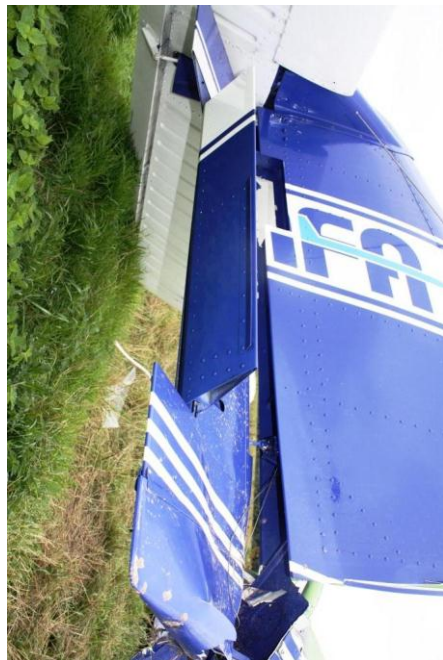
As seen on the following picture, the rudder trim trailing edge was fully deflected to the right.

Figure 12: the rudder trim trailing edge was pointing to the right.

The reason why the rudder trim trailing edge was pointing toward the right was later found to be due to the deformation and displacement of the lower rudder hinge of the rudder.

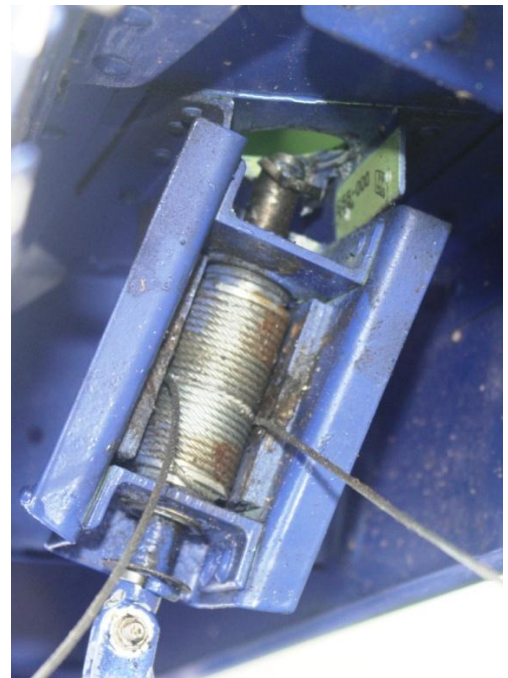
Figure 13: Picture of the rudder trim position.

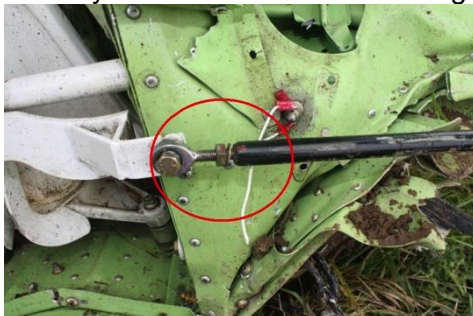
The left hand landing gear was retracted due to a lateral force toward the right that occurred during the accident. Some parts of the retraction system were bent or broken. The right hand landing gear was extended but some parts of the retraction system were bent or broken by a lateral force toward the right that occurred during the accident. A safety nut of the nose wheel bungee rod end was found loose.

Figure 14: view of the nose wheel bungee rod.

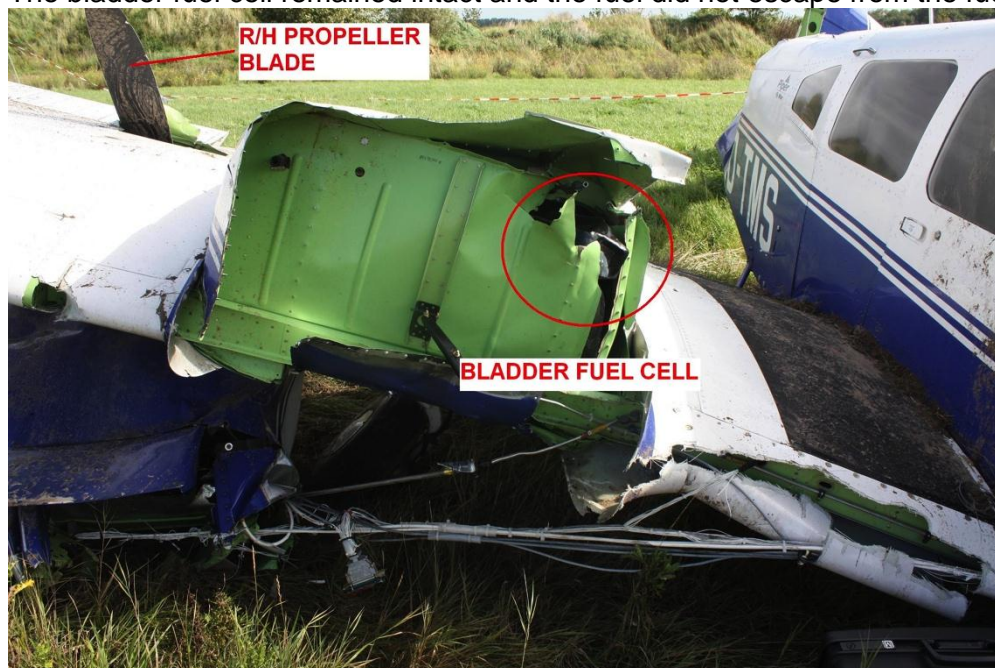
There was neither fuel leak nor fire. However, both engines were ripped off the airplane and as seen on the following picture, the right engine firewall was also torn away leaving the right hand fuel tank unprotected.

Moreover, one propeller blade ran through the wing structure not far from the fuel tank without piercing it.

The bladder fuel cell remained intact and the fuel did not escape from the fuel tank.

Figure 15: view of the right hand engine nacelle structure and fuel cell

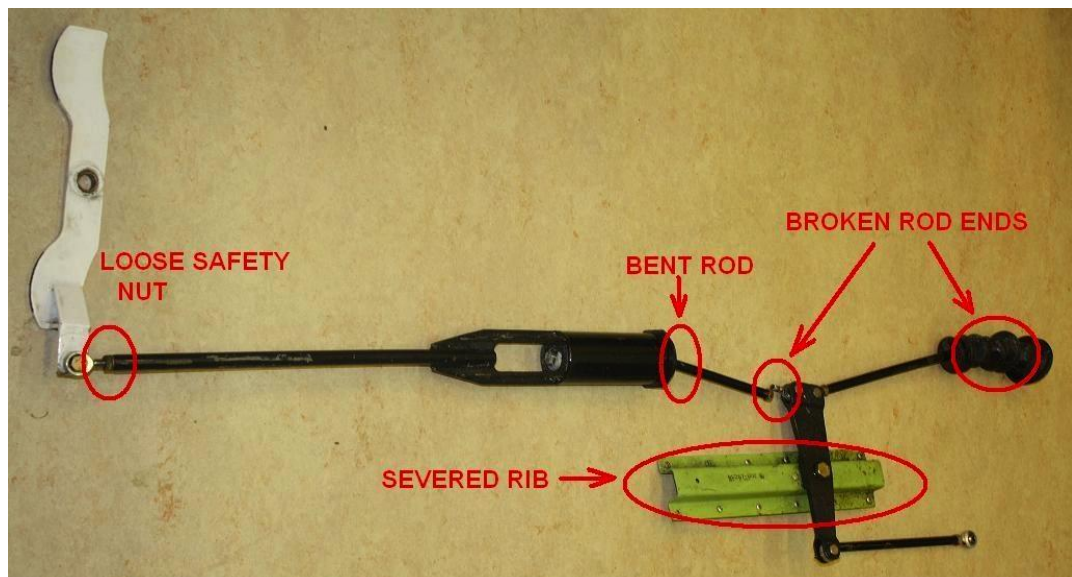
As seen on the following picture the nose wheel steering linkage suffered significant damage when the nose wheel section of the fuselage was severed.

Both broken rod ends have been thoroughly examined in order to determine the type of load that caused the rupture and it could be demonstrated that both fractures were static failures caused by the crash.

The study of mechanical linkage showed a loose safety nut at the bearing rod end located between the steering cam and the nose wheel bungee. However, this could only induce a modification of the rod length involving a possible dissymmetrical position of the rudder pedals when the nose wheel was in neutral position. No pilot reported a dissymmetrical position of the rudder pedals.

The fixation rivets of the rib supporting the nose wheel steering bell-crank were also examined. All of them were pulled out under abnormal static load. There was no trace of fatigue breakage or excessive wear of the rivets.

Figure 18: Nose wheel steering linkage

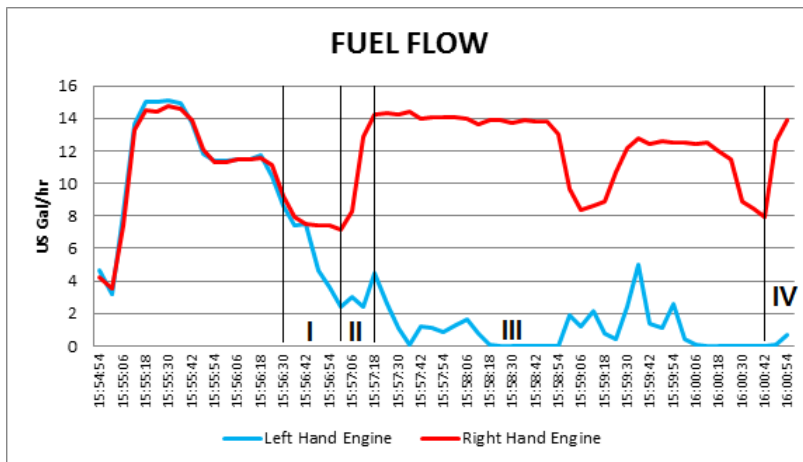
- I: Both Engines reduced**
LH Eng. FF drops after a few seconds.
(Note : Idle FF is 2.5 USG/hr)
- II: Both Engines full throttle**
LH Eng. FF is increasing slowly.
- III: LH Eng. FF erratic - drastically low**
- IV: LH Eng. FF remains low, while full throttle is applied.**

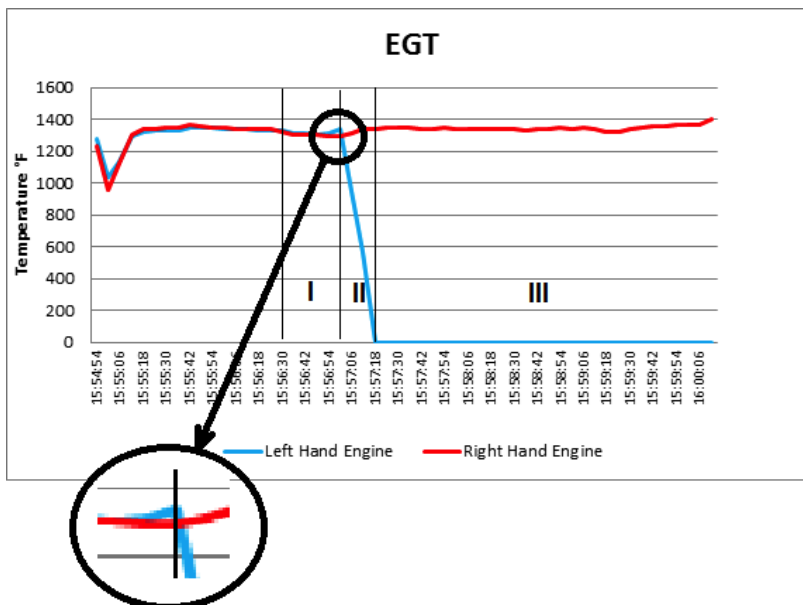
- I: Both Engines reduced**
LH Eng. EGT rises shortly (too lean mixture).
- II: LH Eng EGT drops (towards 0)**
No more combustion in LH engine.
- III: LH Engine not operating.**

The fuel consumption of the L/H engine, for a given value of the Manifold Air Pressure and the RPM was so low that the air/fuel ratio was not flammable anymore.

The L/H engine had virtually stopped operating from 15:56:48 up to the crash 4 minutes later.

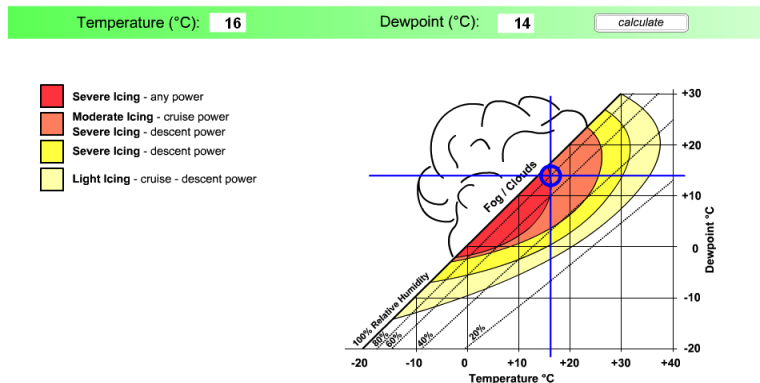
The risk of carburettor icing is related to the air temperature and relative humidity. By the input of these values, you can estimate the approximate probability of carburettor icing by means of the diagram.

Figure 22: Probability of carburettor icing

In flight, the temperature decreases due to the altitude and the relative humidity increases, moving towards “Severe Icing” in any power. Obviously, the meteorological conditions were likely to induce carburettor icing, particularly in descent power.

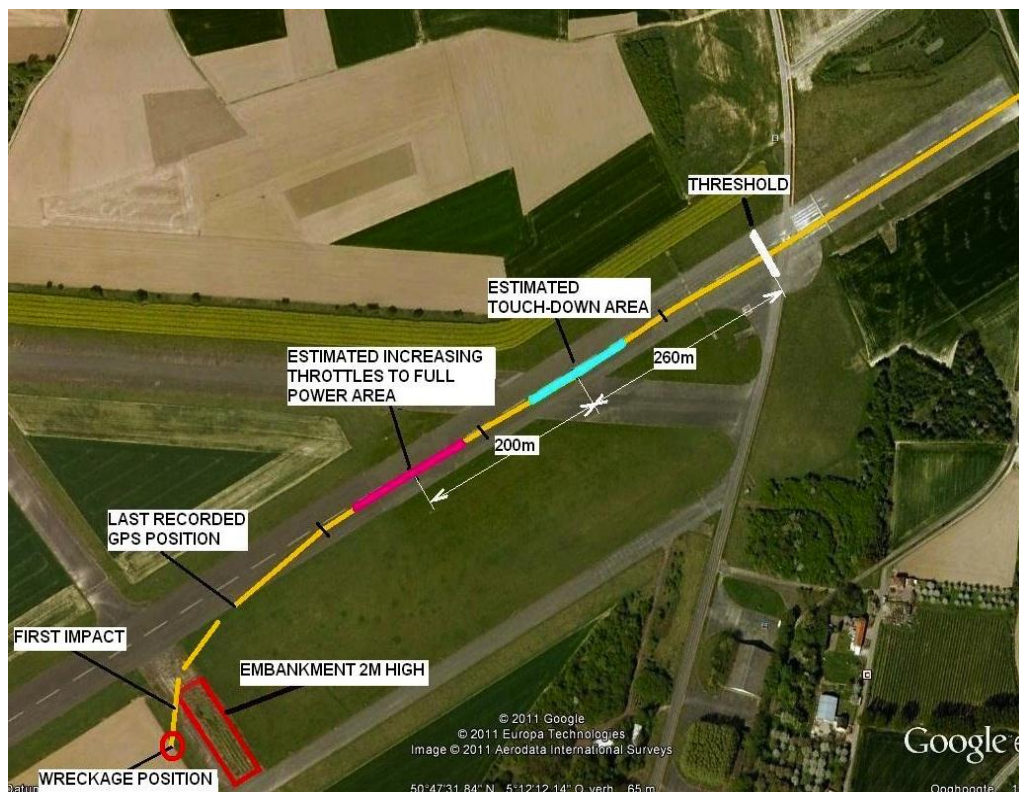
As seen on the following picture, the touch down was performed around 260 m beyond the threshold and the increasing of the throttles to full power was done around 460 m after the passage above the threshold.

That means that 740 m runway was still available in front of the airplane when full power was applied. At this moment, there was sufficient time available to slowly increase the power of both engines in order to assess their response.

Figure 23: Estimated touch down area and full power setting area
