Federal Public Service
Mobility and Transport
Air Accident Investigation Unit

Safety Investigation Report

ACCIDENT TO PIPER PA-44-180 AT EBST ON 11 SEPTEMBER 2011

Ref. AAIU-2011-23
Issue date: 14 January 2013
Status: Final

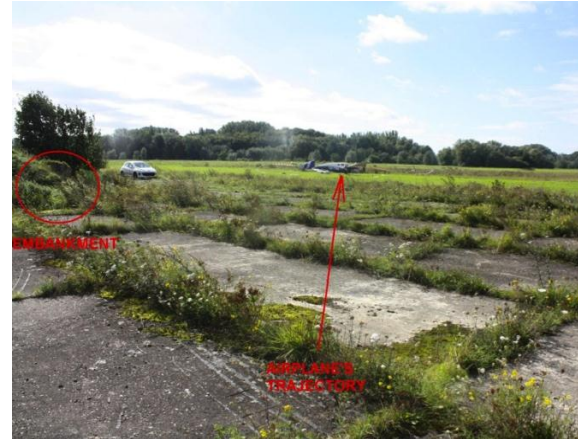
Figure 8: airplane's trajectory and view of the embankment

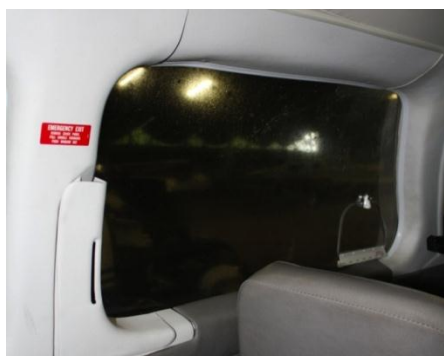
The emergency exit consisting in an opening in the left side front window was not used to evacuate the aircraft.

Figure 16: view of the emergency exit (Not used after the crash).

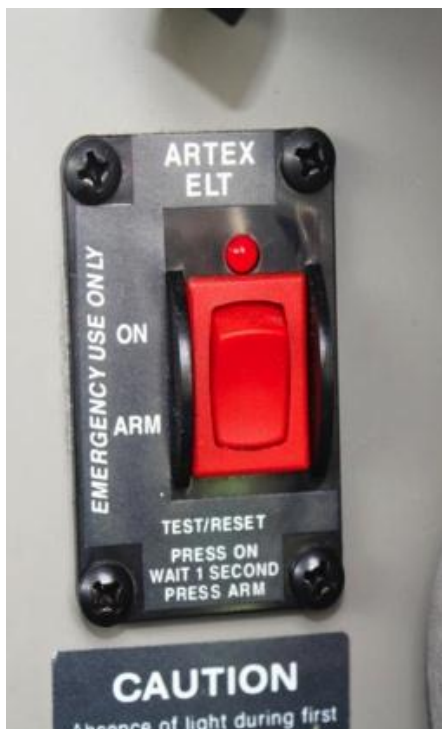
Figure 17: ELT Switch installed on Dashboard.

AAIU (Be) recommends the BCAA to prepare a change in the Belgian Regulation in order to comply with ICAO Annex 6 Part II “International General Aviation – Aeroplanes” Chapter 2.4.12 about the Emergency Locator Transmitters and to consider extending the requirements of carrying ELT’s to national flights to improve the survival chances of injured persons in case of accident.

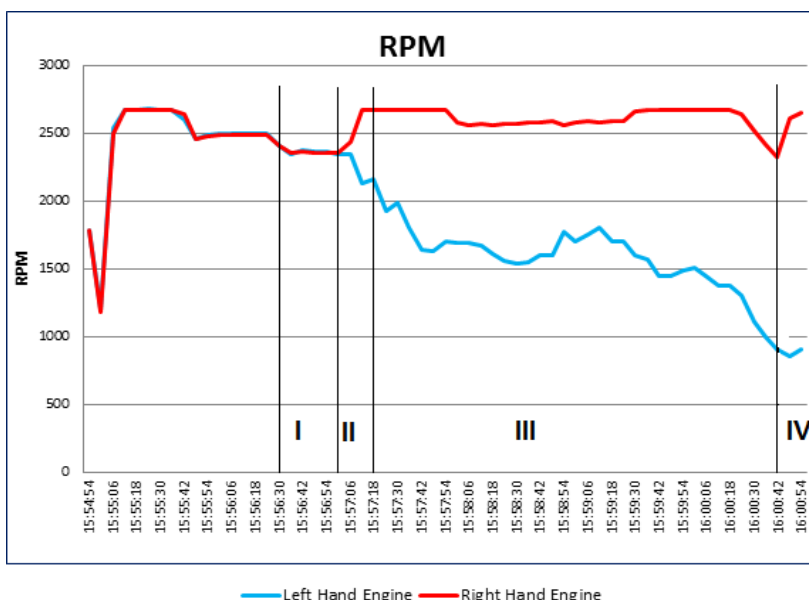
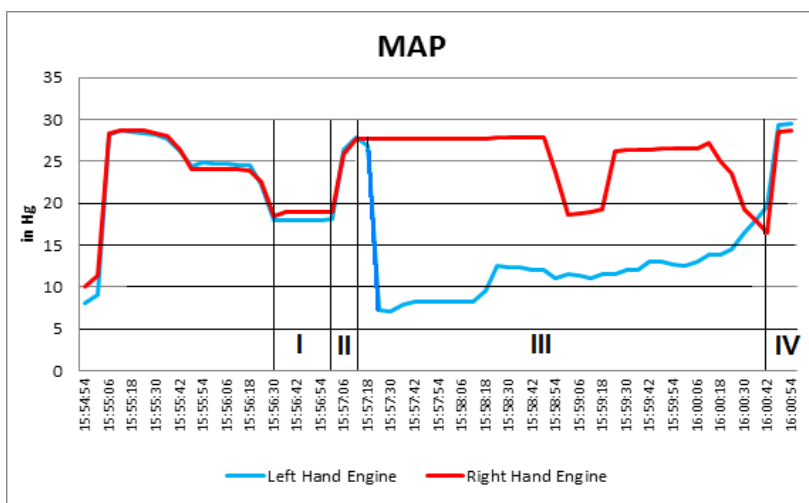
- I: Both Engines reduced**
LH Eng. FF drops after a few seconds.
(Note : Idle FF is 2.5 USG/hr)
- II: Both Engines full throttle**
LH Eng. FF is increasing slowly.
- III: LH Eng. FF erratic - drastically low**
- IV: LH Eng. FF remains low, while full throttle is applied.**

The fuel consumption of the L/H engine, for a given value of the Manifold Air Pressure and the RPM was so low that the air/fuel ratio was not flammable anymore.

The L/H engine had virtually stopped operating from 15:56:48 up to the crash 4 minutes later.

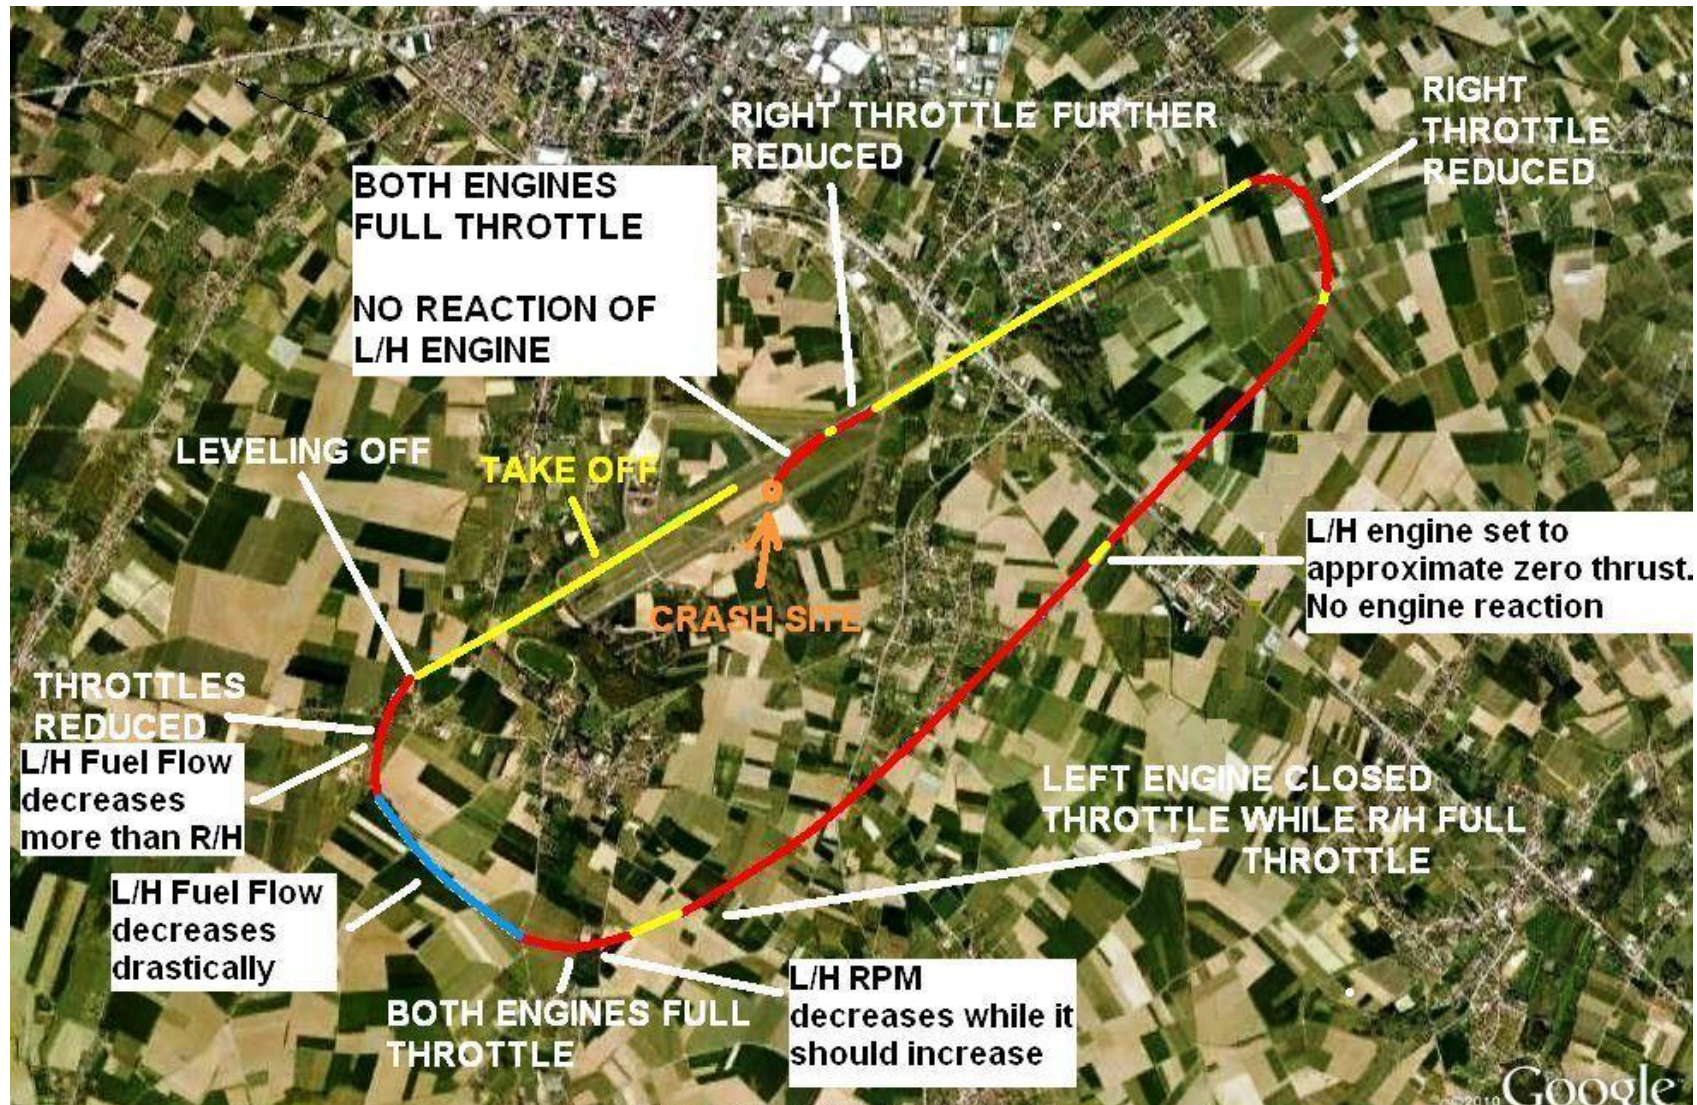
Figure 19: Last circuit interesting steps

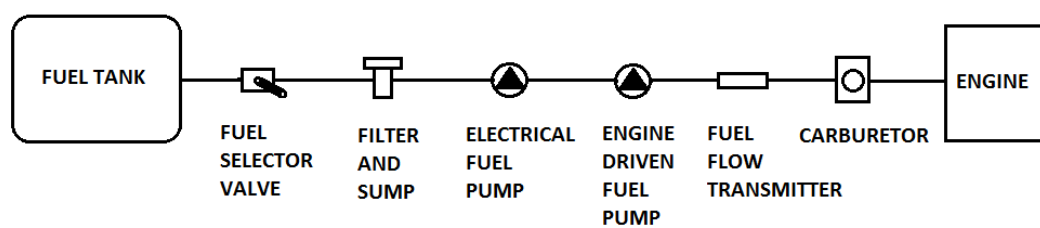
As the fuel flow of the L/H engine dropped significantly within a very short period of time, the airplane fuel system and the L/H engine were thoroughly inspected. The fuel filters, the carburetor and the mechanical fuel pump of the L/H engine were thoroughly inspected. In particular, the carburetor was completely dismantled and examined in order to find any contamination or sign of anomaly. No pre impact fuel leak and no anomaly in the airplane's fuel system were found.

Figure 20: Schematic fuel circuit for one engine (Note: Entire fuel system schematic on Figure 21).
